CASE STUDY

Successful CIF funding bid for Lightcliffe Academy roof renewal by SIG

Project: Lightcliffe Academy, Halifax

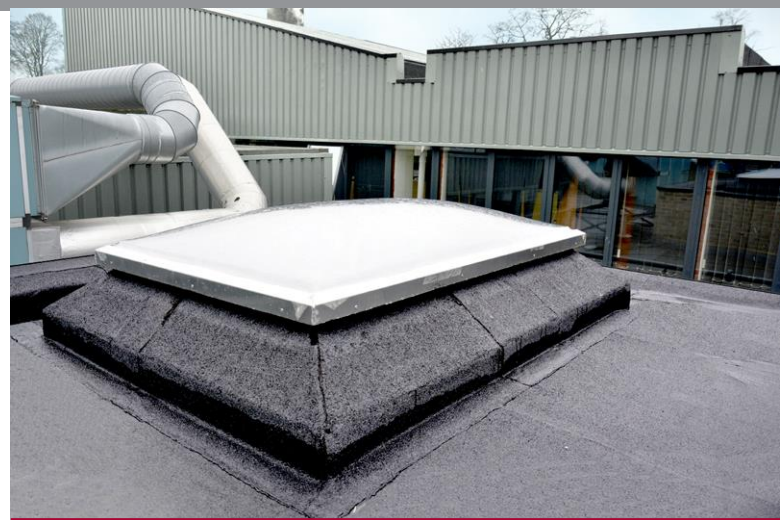
The existing fragile glass roof lights have been replaced with triple skinned roof domes which have been tested for safety and strength

The inspection revealed that some of the roofs had old glass roof lights fitted with Georgian wired glass. These were very fragile and represent a significant risk to anyone working on the roof. They were replaced with new triple skinned roof domes which have been tested for safety and strength.

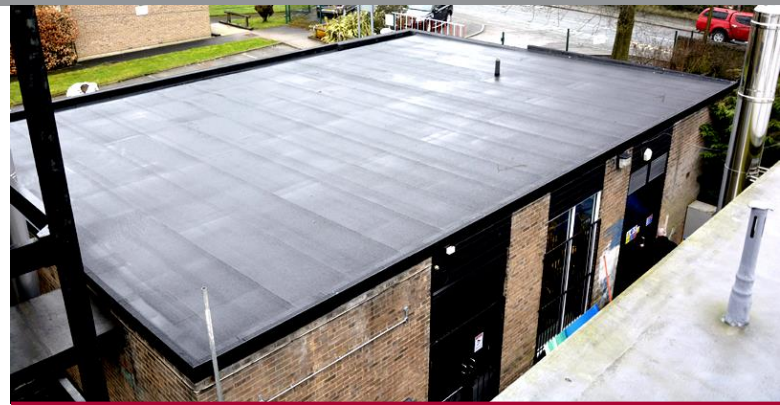
During the inspection, serious problems with the metal decks came to light. Every deck inspected at the academy had been laid the wrong way around, so that instead of draining down the fall, rain water sat in troughs causing internal rusting.

Stripping the roof away on the boiler house revealed a rusting metal deck due to water sitting in the deck troughs

Stripping the roof away revealed an important discovery. Water sitting in the deck troughs, meant it had rusted through due to apparent failure of the waterproof layer.

Once the metal decks were repaired, the roofing contractors installed a new SIGnature metal lined Vapour Control Layer (VCL), which was torch bonded to the repaired metal deck.
