CASE STUDY

Successful CIF funding bid for Lightcliffe Academy roof renewal by SIG

Project: Lightcliffe Academy, Halifax

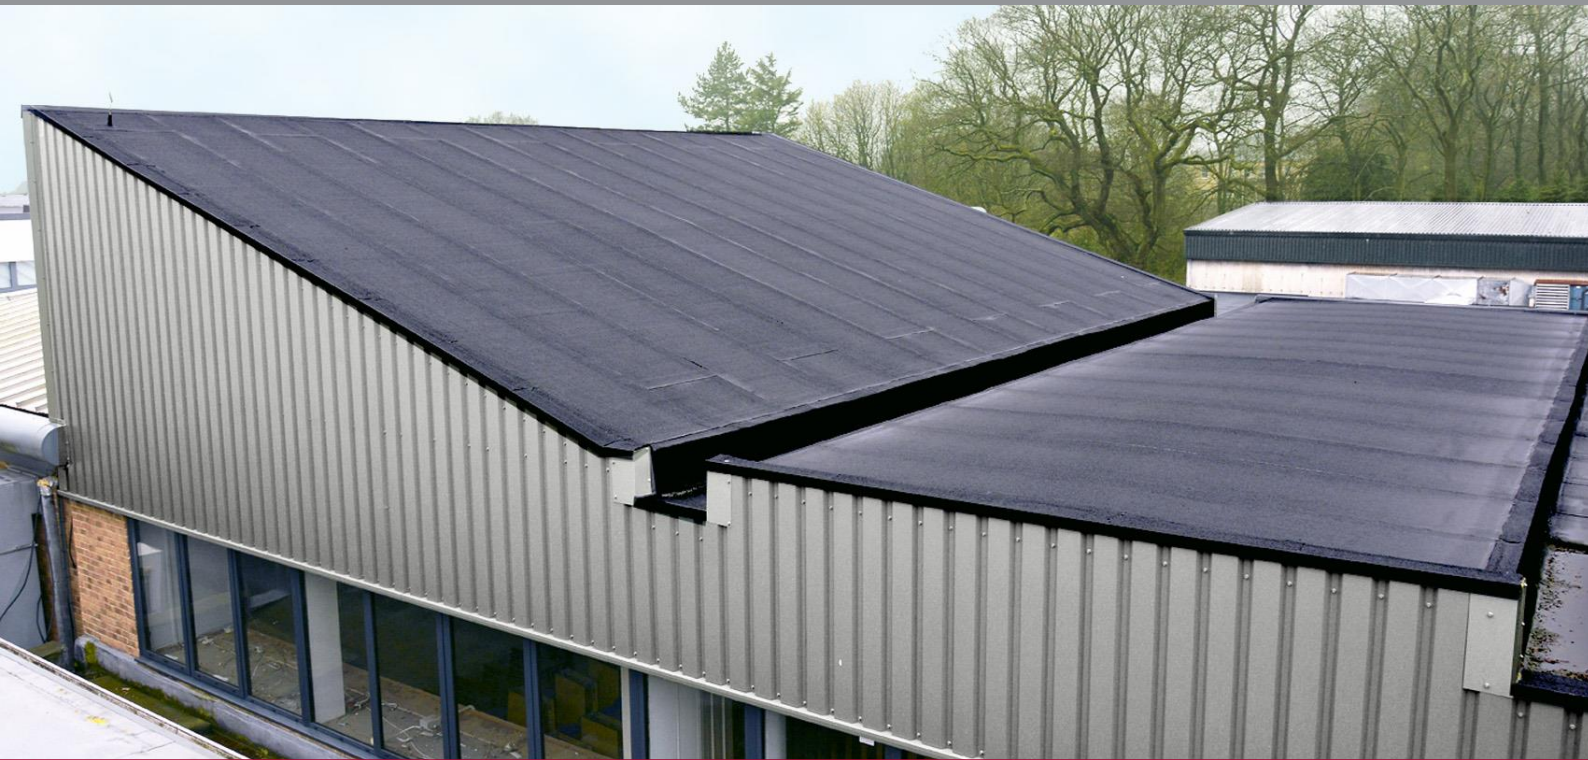
This clearly meant the roof was no longer structurally sound, however, SIG's Health and Safety procedures had prepared the roofing contractors for such eventualities.
